## Technical Bulletin

### Clutch Set

Smooth engagement of gearbox with engine after clutch replacement

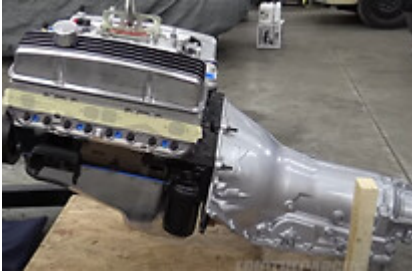
Consequence at vehicle is the alignment tool not used during fitment

Difficult in engine Transmission alignment

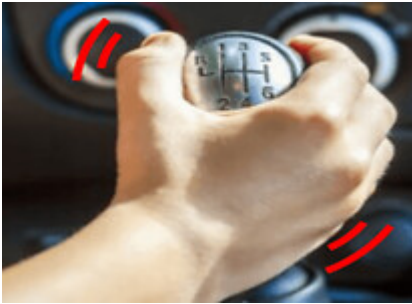
Hard gear shifting/ Gear not able to shift

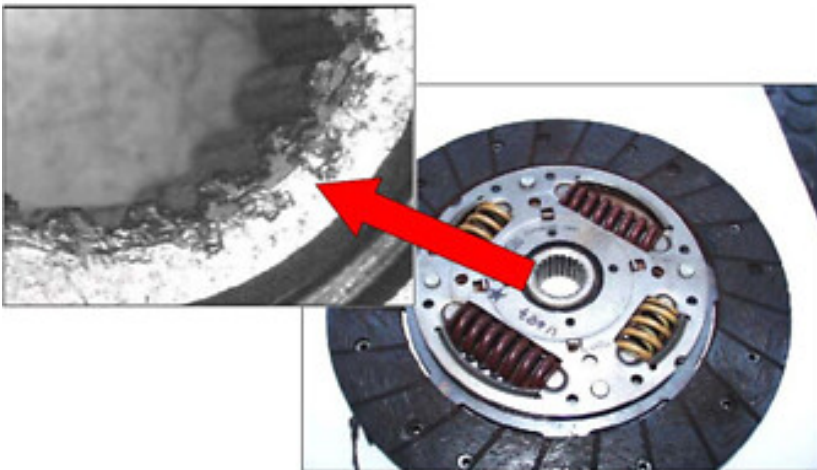
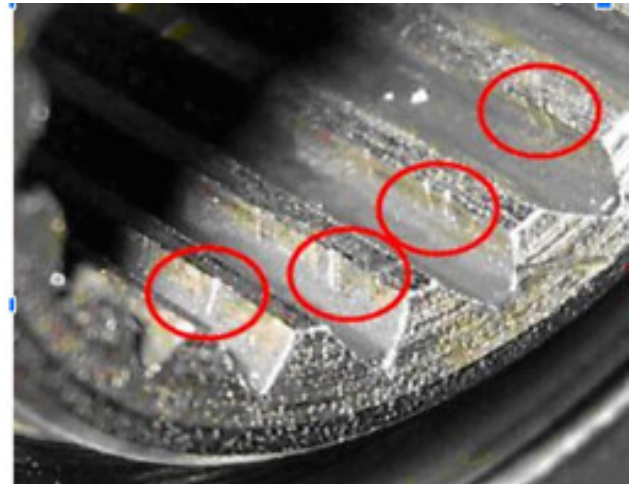
**Consequence in the Clutch disc spline**

1. **Above observation of spline damages is result of negligence of alignment tool during mounting.**
2. **Such conditions are not warrantable due to wrong fitment practice**
