Technical Bulletin

All Clutches

Passenger Cars

How to Diagnose - Squeaking Noise from Transmission

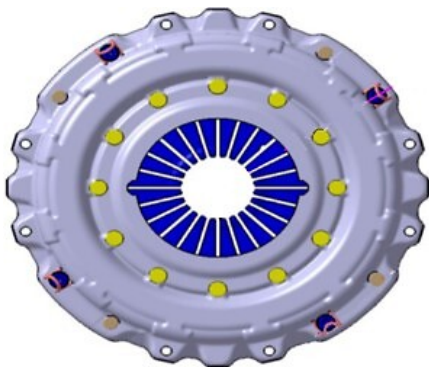
The Valeo Service Quality department have received several claims stating that after fitment of clutch kits, there is a noise arising from the transmission. However, the noise disappears when the clutch pedal is depressed and the transmission is in neutral. Upon inspection of the vehicle, it was found that there is no manufacturing defect with the clutch and the root cause of the squeaking noise is due to **a faulty or worn gearbox input/output shaft bearing**.

Bearings are designed to provide long life, but can fail due to lack of lubrication, dirt contamination and improper adjustment. The first symptom of bearing failure is a noise from the part associated with the faulty bearing.

Solution: Valeo recommend that the input/output shaft bearings are checked and replaced if necessary.

Check the input/output shaft bearings and replace if necessary
