Technical Bulletin

Clutch Disc

Clutch Disc Failure Diagnostic

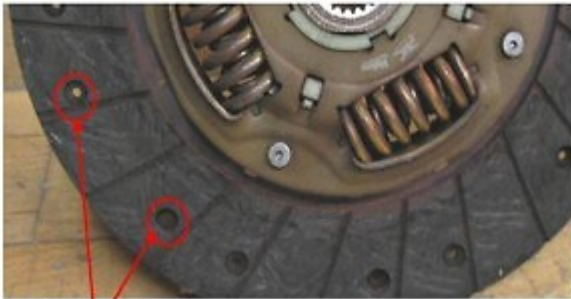
Juddering

ANOMALY OBSERVED

Linings can move on the drive plate

POSSIBLE CAUSE

- The exentation between the gearbox and the engine generation important shaking on the cushion disc and the rivet and deteriorate the linings fixations points.

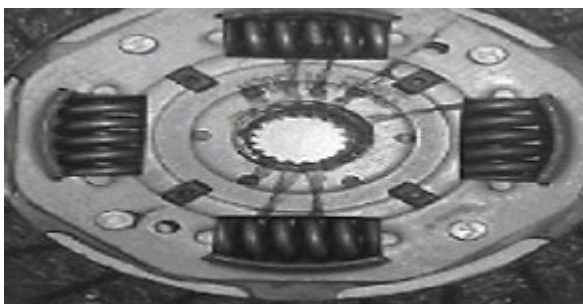
Neutral gears noises

ANOMALY OBSERVED

Centrifugation of grease on the hub drive plate. That alter the damping

POSSIBLE CAUSE

- The pollution on the drive plate is irreversible, clean it will not remove the problem
- When reinstalling the new clutch, lubricate moderately with grease the bearing guide and the fork fingers

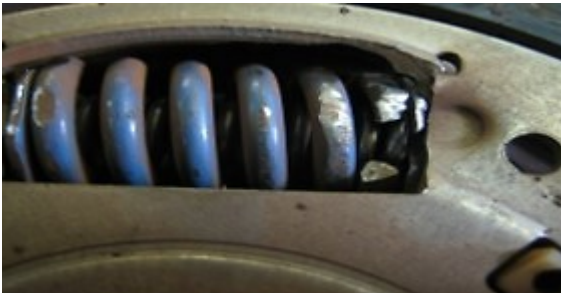
Machine gun noise coming from the gearbox

ANOMALY OBSERVED

One or more turns of the damper spring was broken that alter the filtration

POSSIBLE CAUSE

- A too important engine acyclism (injection, combustion, fuel...)
- a gearbox exenturation or an oscillation of the primary shaft.
- The centering pins on the engine are damaged and the gearbox is not correctly aligned.

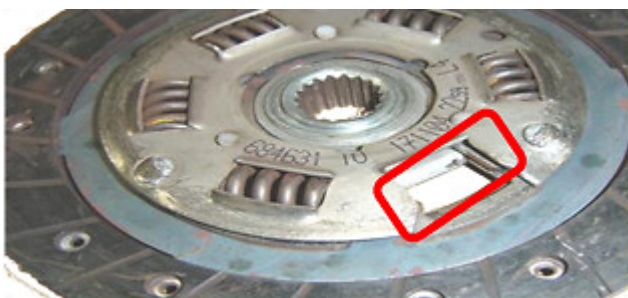
Machine gun noise coming from the gearbox

ANOMALY OBSERVED

The Oscillation of the gearbox primary shaft stress the retainer plate of the drive plate.

The spring force on the retainer plate until it complete breakage

POSSIBLE CAUSE

- At the time of the gearbox accosting, it is recommended to maintain the engine and the gearbox aligned by using hoist or jack until their fixing

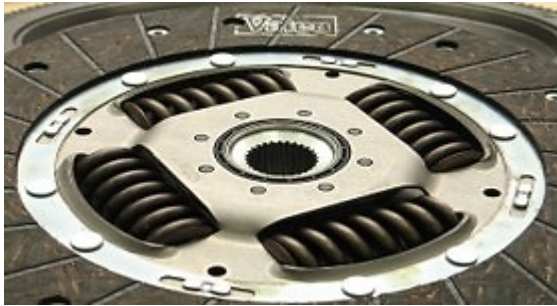
Dampers move freely

ANOMALY OBSERVED

The clearance of the filtration springs is not a defect. This clearance permits filtering of the engine acyclism when the gearbox is in neutral

POSSIBLE CAUSE

- When the engine is running, the springs are subjected to the engine torque and the clearance in the springs is cancelled due to the centrifugal force.

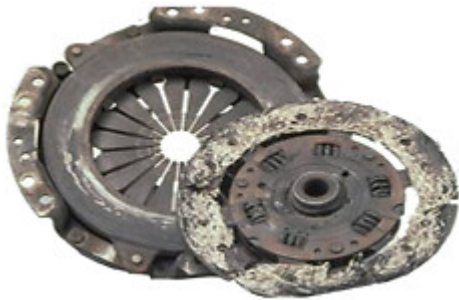
Slipping

ANOMALY OBSERVED

Linings are totally worn

POSSIBLE CAUSE

- A bad return of the bearing due to the wear of the command system
- The presence of the driver foot on the clutch pedal
- Severe conditions of use, an overloaded trailer
- Remapped engine with to important torque transfert.

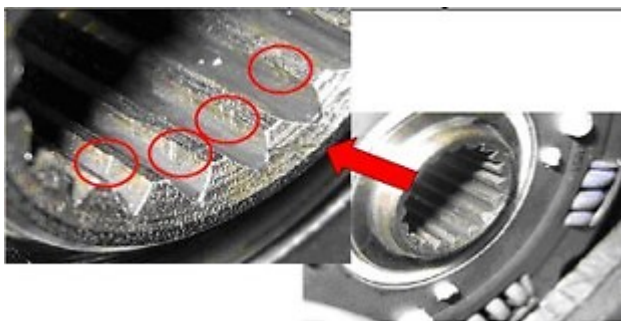
Bad speed changeover / Impossibility of speed changing

ANOMALY OBSERVED

Deterioration of the hub grooves

POSSIBLE CAUSE

- Exertion of force on the gearbox primary shaft in the friction hub is responsible for the deterioration of the hub grooves. (presence of significant burrs and material displacement).

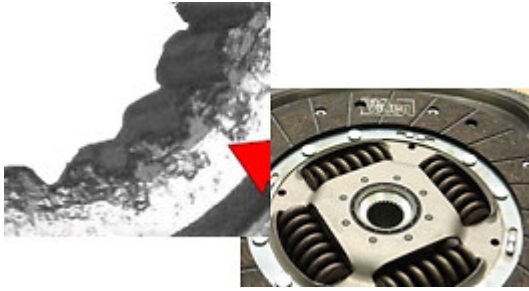
Impossibility of speed changing

ANOMALY OBSERVED

Destruction of the hub grooves

POSSIBLE CAUSE

- The destruction of the grooves is probably caused by an abnormally high driving acyclism
- These impacts have generated mechanical stress up to the level of shearing the grooves.

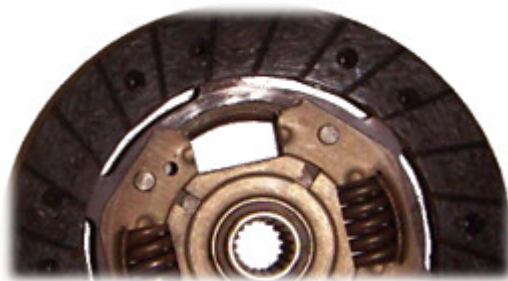
Impossibility of speed changing

ANOMALY OBSERVED

Spring ejected

POSSIBLE CAUSE

- A strong engine acyclism is probably the cause of the ejection of the damper spring and the deterioration of the others. The ejected spring settles in the sector of the diaphragm articulation in the clutch mechanism.
- Then the mechanism can no longer ensure release of the clutch.
