Technical Bulletin

Clutches

Causes of Slipping and Juddering complaints

To address the problems of Slipping and juddering Clutch complaints due to Friction disc contaminated by engine oil

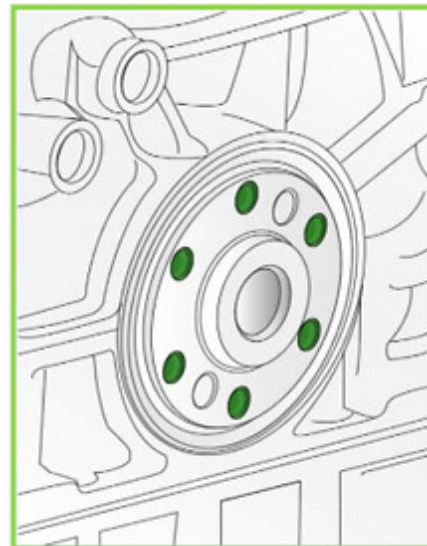
The Valeo Service Quality department have seen several clutch kits returned that are contaminated with oil. The oil found on the components can only of originated from the rear crankshaft seal.

The inside of the rear main seal maintains contact with the crankshaft as it is spinning around thousands of times a minute. The crankshaft seal is also next to one of the main bearings in the engine, which needs to be constantly lubricated by oil. If the seal is damaged, the constant bath of oil combined with the spinning motion of the crankshaft will cause a rear main seal leak and allow a significant amount of oil to leak from the engine as it's running. If the crankshaft seal dries out, cracks, or breaks, it can cause an oil leak.

Valeo Service advise always checking the rear crank shaft seal during every clutch change to ensure that there are no leaks present and the seal is in good condition. If oil is found on the flywheel and can be seen leaking from the rear crankshaft seal then Valeo advise addressing the leak immediately and replacing the seal if required.
